Manhole Inspection Summary

Manhole # S03YY1024MH

Location Address: **3315 PARKINGTON AVE** Cross Street: **DOVERDALE DR**

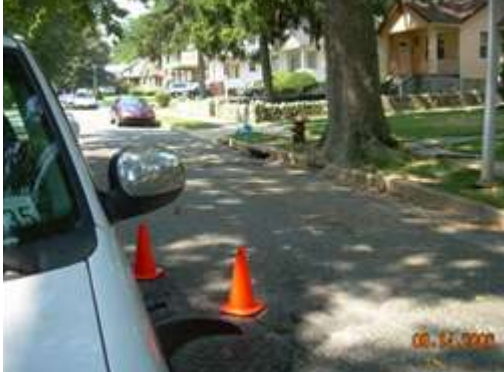
Location View

Comments **Hole in road next to manhole. May be a source of infiltration.**

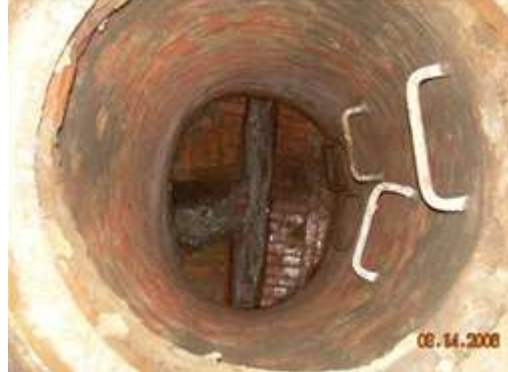
Top View

Bench ☒ Exists Material: **Brick** ☐ Parged ☒ **Debris** (not Condition related)
Condition: ☒ Sound ☐ Cracked ☐ Root Intrusion ☐ Deteriorated ☐ Leaks ☐ Debris

Steps Count: **5** Missing: **0** ☒ **Corroded**

Surcharge ☒ **Evidence Of Surcharge** Depth: **3** (ft.) ☐ Active Surcharge Present

Corroded steps. Evidence of surcharge - Bench debris.

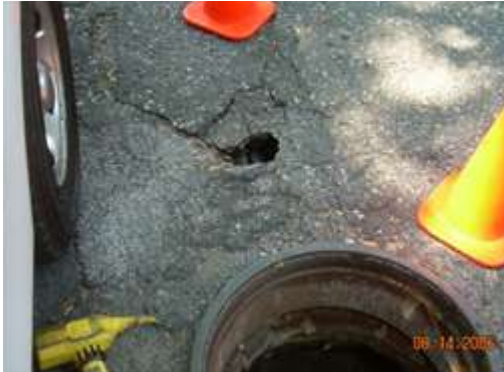
Defect

Hole in the road beside the MH.

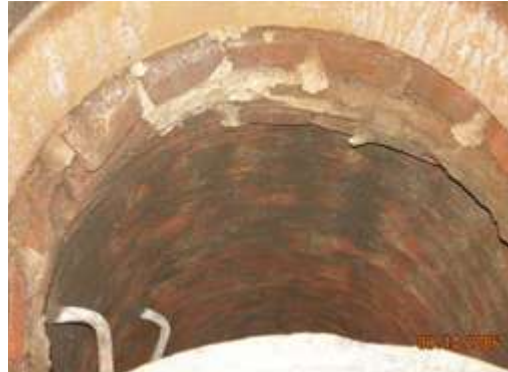
Defect

Frame Offset: **0** (in.) Condition: ☐ Sound ☐ Cracked ☒ **Leaks**

Chimney / Frame Adjustment ☒ Exists Material: **Brick** ☐ Parged Height: **10** (in.)
Condition: ☐ Sound ☐ Cracked ☐ Root Intrusion ☐ Loose Brick ☒ **Deteriorated**
Infiltration: ☐ None ☒ **Joint** ☐ Cracks ☒ **Mortar** ☐ Roots ☐ Wall

Corbel Material: **Brick** ☐ Parged Type: **Concentric/Eccentric**
Condition: ☒ Sound ☐ Cracked ☐ Root Intrusion ☐ Loose Brick ☐ Deteriorated
Infiltration: ☐ None ☐ Joint ☐ Cracks ☒ **Mortar** ☐ Roots ☒ **Wall**

Barrel Material: **Brick** ☐ Parged
Shape: **Circular** Diameter: **48** (in.) Length: (in.)
Condition: ☒ Sound ☐ Cracked ☐ Root Intrusion ☐ Loose Brick ☐ Deteriorated
Infiltration: ☐ None ☐ Joint ☐ Cracks ☒ **Mortar** ☐ Roots ☒ **Wall**

Frame leaks. Frame offset. Adjustment deterioration and infiltration. Corbel and Barrel infiltration.

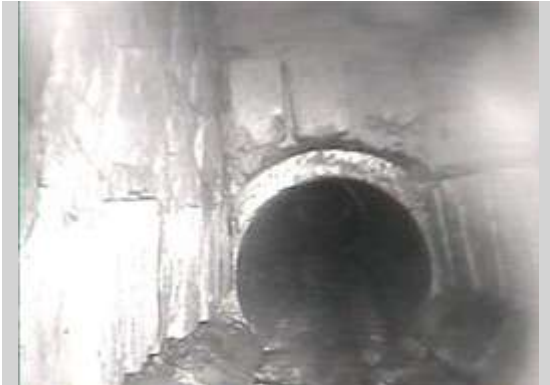
8 in. Circular Gravity Sewer Pipe Out @ 12 O'Clock

Infiltration: **Evidence** Pipe Seal Cond: **Unknown**

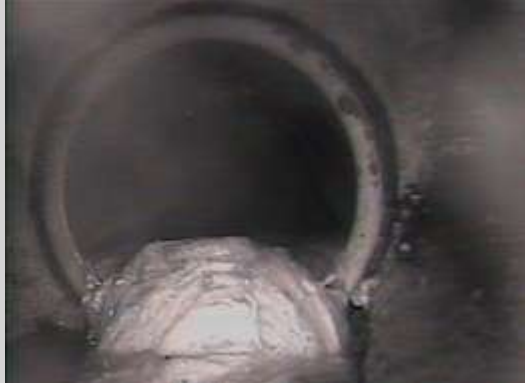
Pipe In @ 9 O'Clock

Deposits: ☐ None ☐ Mud ☐ Sludge ☒ **Debris** ☐ Grease

Deposits Extent: **Light**

Infiltration: **Evidence**
